INVENTORY FORM FOR STATE HISTORIC SITES SURVEY

SNYDER FARM BARN

Addendum to original form

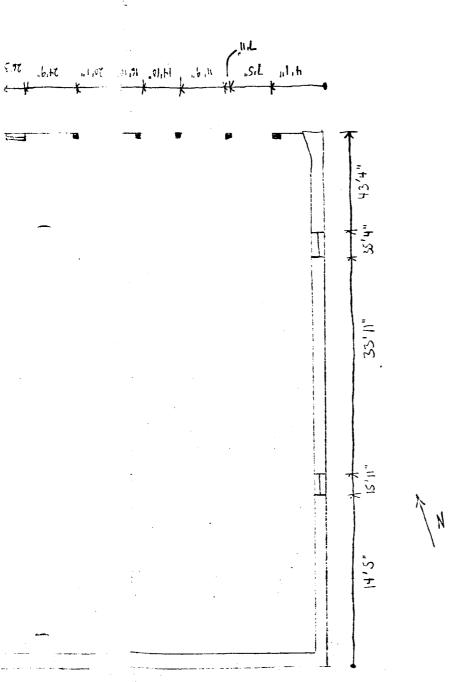
WA- I- 179 Snyder Fain Barn

Foundation Level

scale - 1/8" = 1 foot

The interior of the foundation level has a large open room in the easternmost section. The westernmost section is divided into pens with a central aisle, an aisle along the south foundation wall, and a section of four pens on the east side and six pens on the west side of the central aisle. The pen arrangement includes hay mangers constructed of rounded dowals running through the stalls. The main floor contains a small partitioned office in the southeast corner of the structure that is now used for Blairs Valley Lake. The remainder of the main floor is open to the ceiling and contains framing system with bracing to support two principle parlins that carry the common rafter through. The framing is mortised, tenned, and pegged.

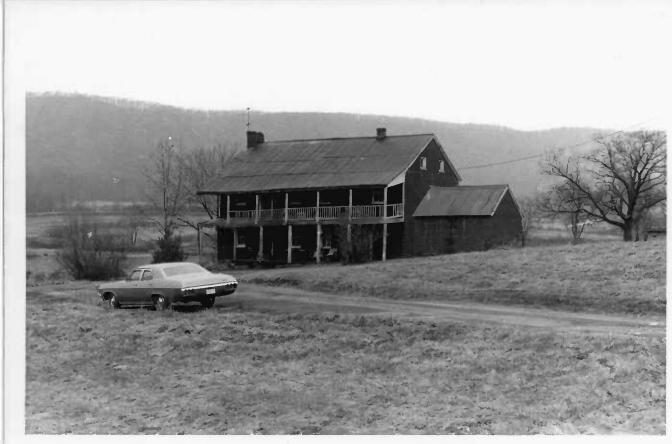
WA-V-179 Incliain Springs WMA "Snyder Farm, N.W. View Dec. 1978

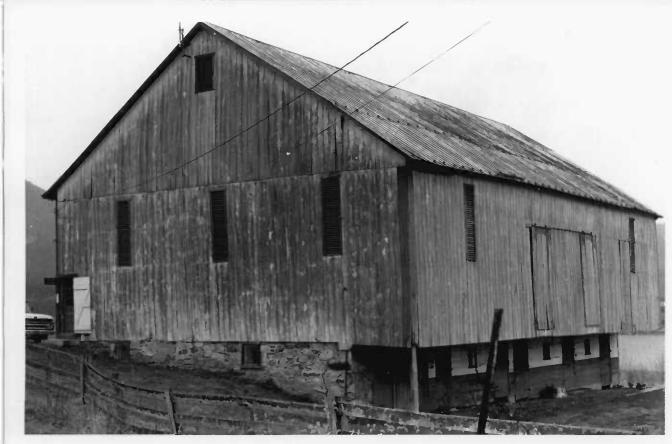
Indian Springs Lutdlife Manag. Area Snyder Farm - Ban S. W. View
